**CERCLA  
Site Reassessment**

**South California Chemical  
Union, Illinois  
ILD 059483081**

**PREPARED BY:  
ILLINOIS ENVIRONMENTAL PROTECTION AGENCY  
BUREAU OF LAND  
DIVISION OF REMEDIATION MANAGEMENT  
OFFICE OF SITE EVALUATION**

**April 30, 2018**

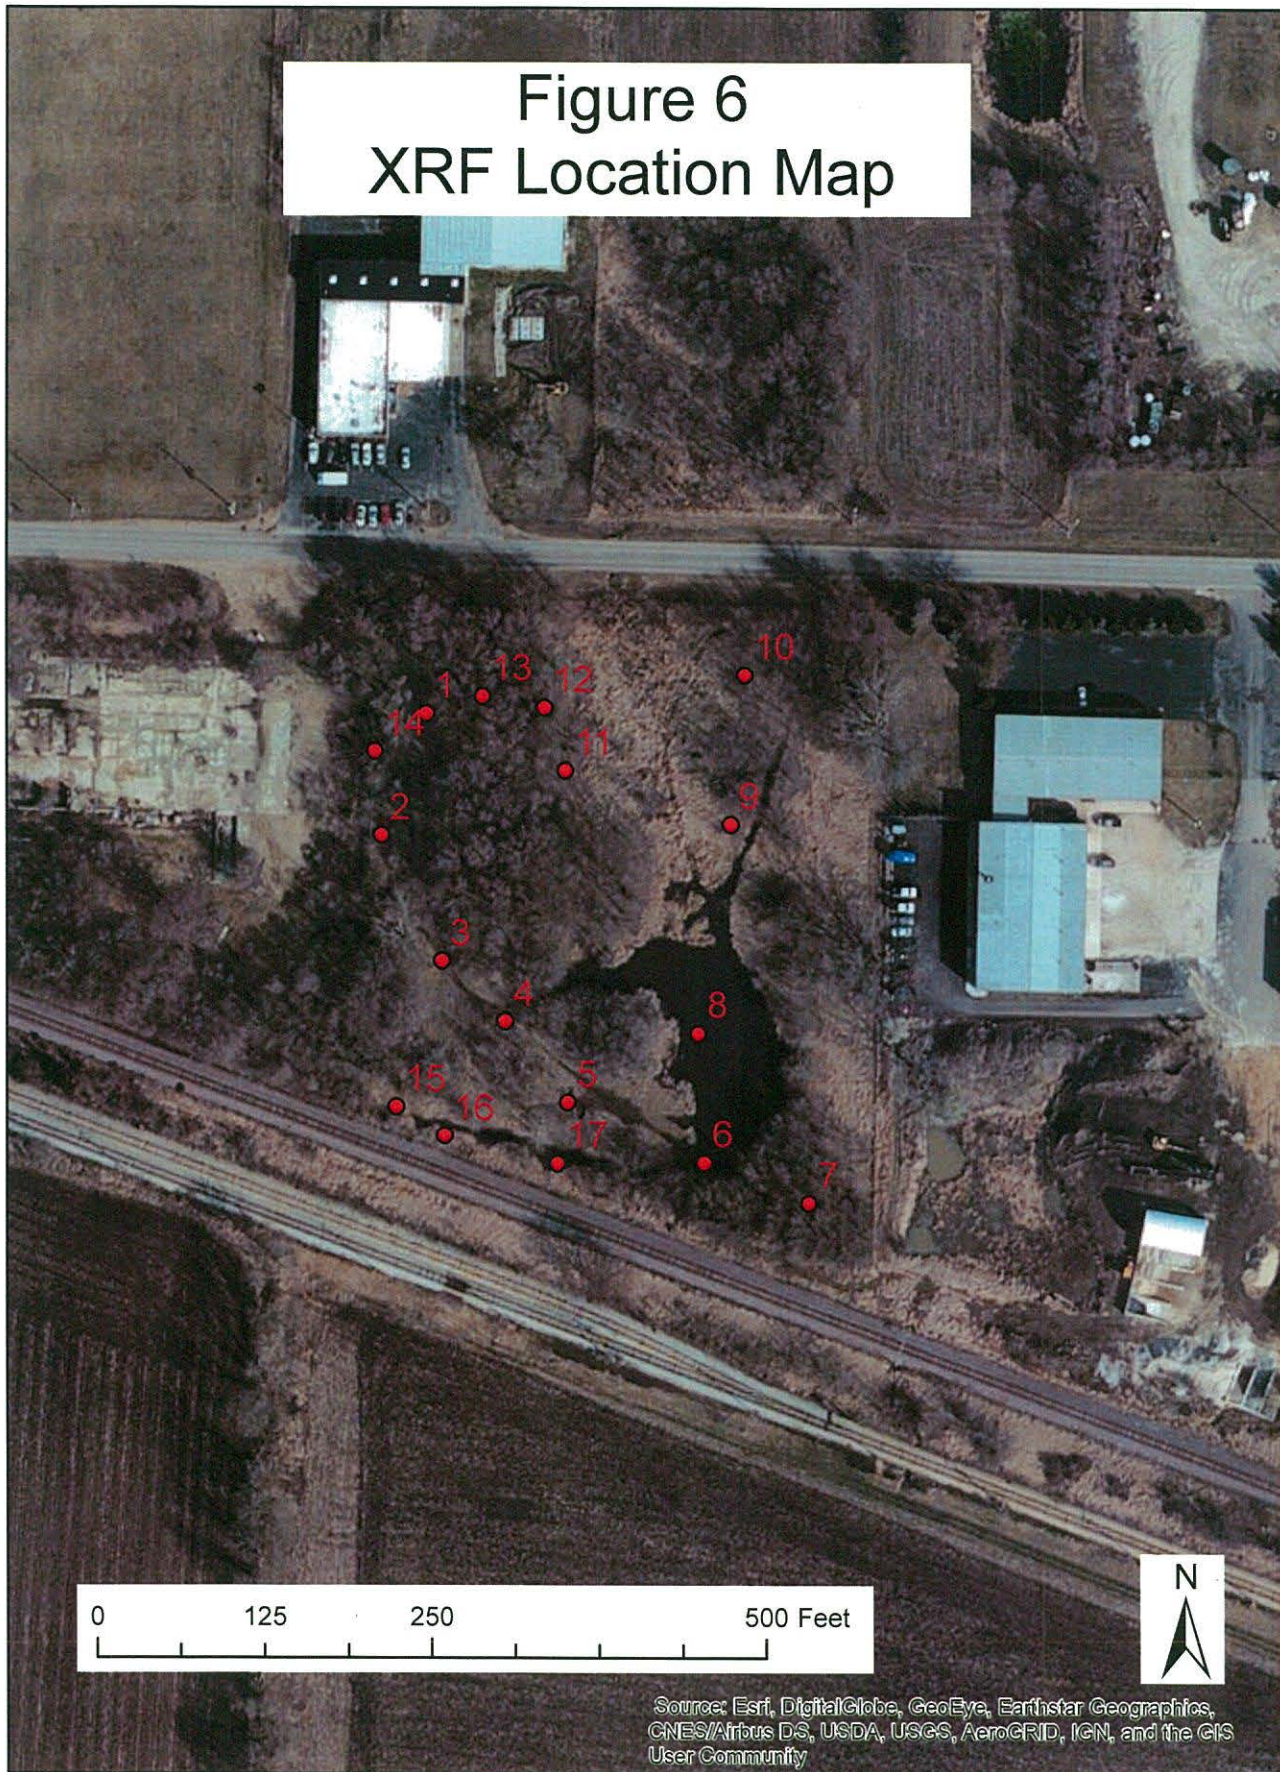
Figure 6  
XRF Location Map

Stainless steel trowels were used to scan various locations at various depths with an X-Ray Fluorescence (XRF) instrument (see Figure 6 and Attachment C). Two of the contaminants of concern for this site (lead and copper) were recorded in the field in a logbook (see Attachment A). The XRF screening locations were recorded using a Trimble Global Positioning System (GPS). The locations of all of the screened locations are depicted in the Figure 6 XRF Location Map.

Soil locations were field analyzed using an X-Ray Fluorescence (XRF) instrument. The XRF is a screening tool that is used in order to determine which depths of the sample locations contain the most potential for soil contamination. Two locations screened, XRF #13 at a depth of 5 inches and XRF #15 at a depth of 8 inches, showed copper in exceedance of the residential RML (9400 mg/kg) with XRF #15 also exceeding the Industrial RML (140,000 mg/kg). Also, XRF location #6 at a depth of 3 inches showed lead exceeded the Industrial RML (800 mg/kg). The XRF results are not meant to replace analytical lab results. The XRF results are presented in Attachment C.

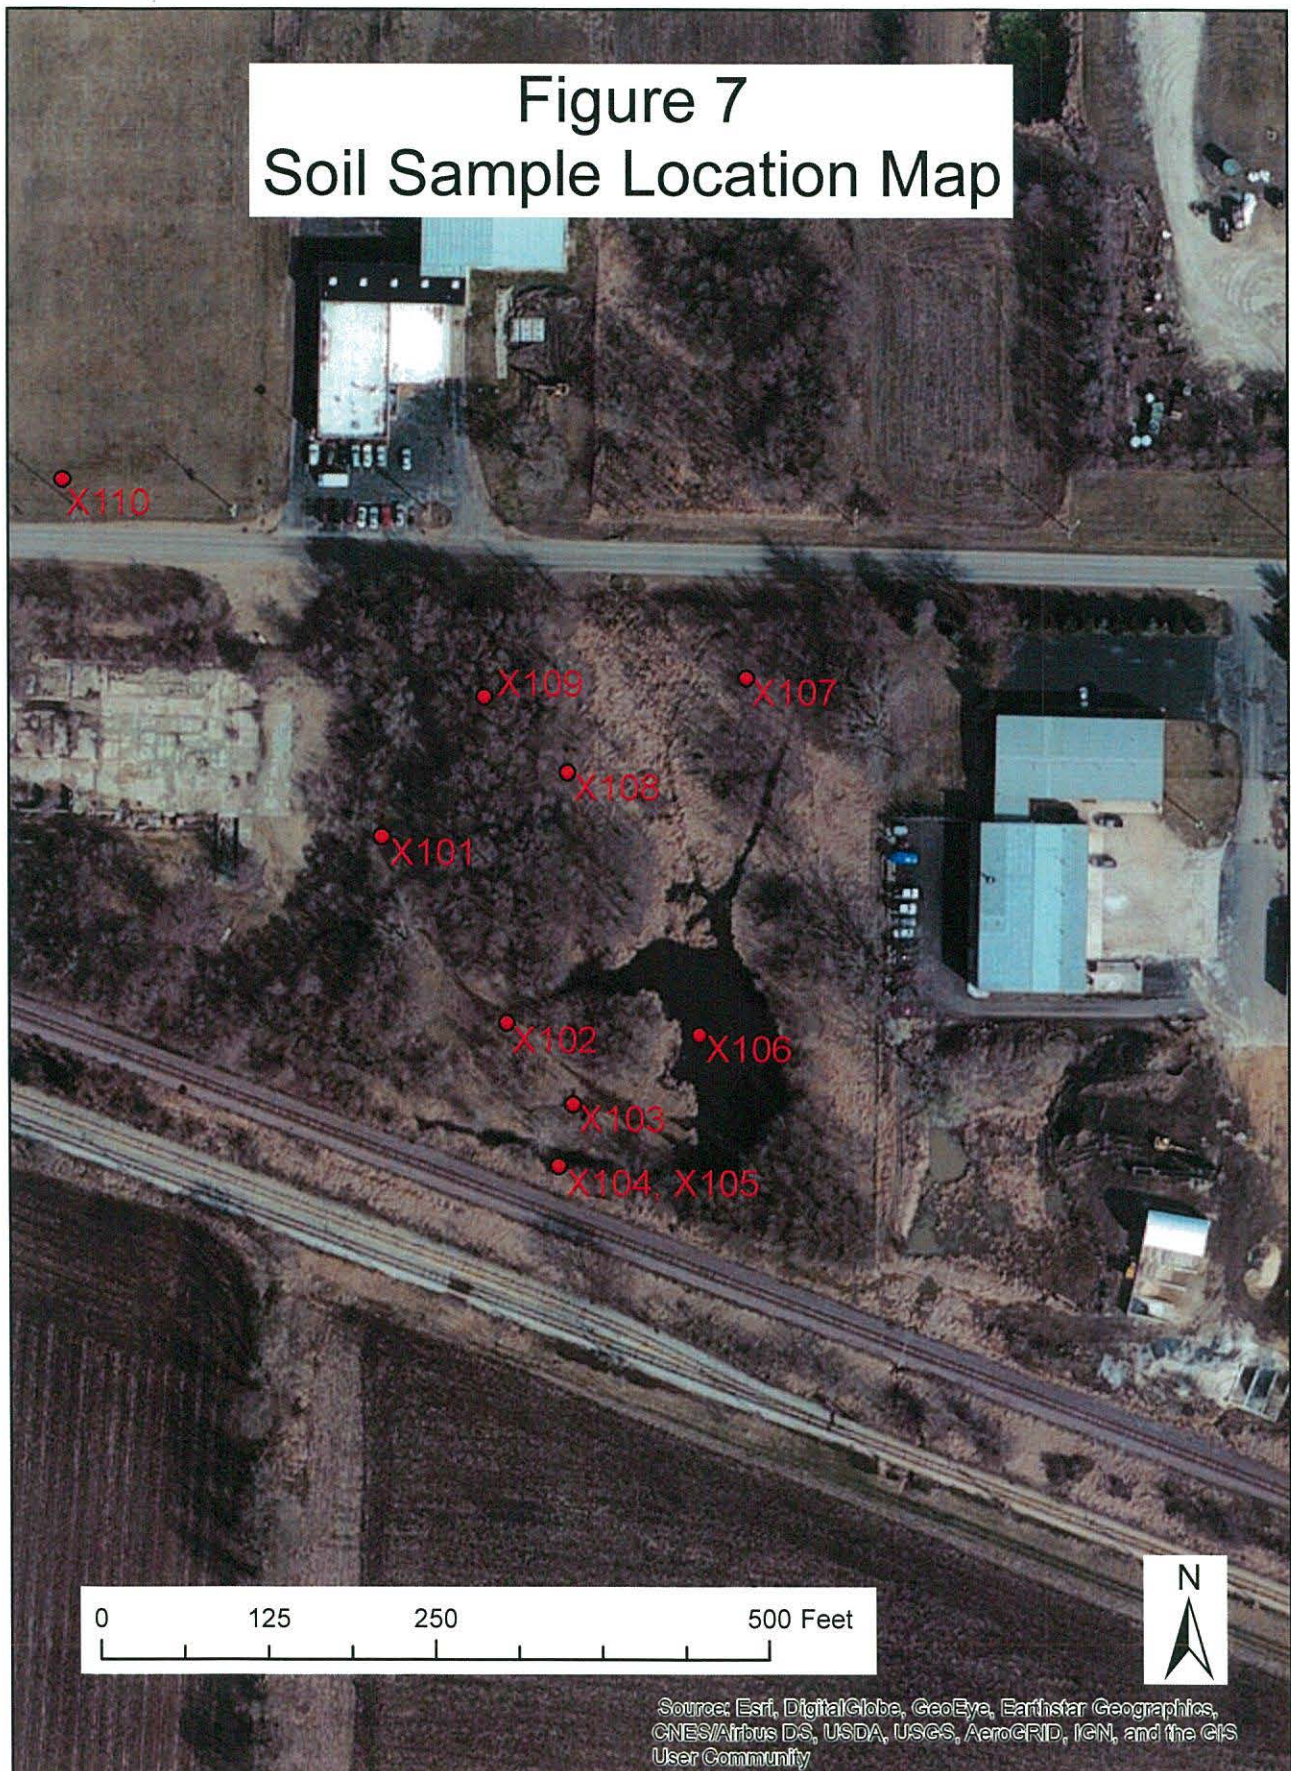
Figure 7  
Soil Sample Location Map

Fourteen samples (X101-X113) were collected at nine of the previously XRF screened locations. Sample X105 is a duplicate sample of X104 taken for Quality Control/Quality Assurance purposes. The locations were chosen based on the results of the XRF screening and relocated using the GPS. Sample X110 was taken as the background sample. Samples were collected into glass jars using stainless steel hand trowels at the depths with the most suspected contamination and in the top three feet. The locations of the soil samples are depicted in the Figure 7 Soil Sample Location Map.

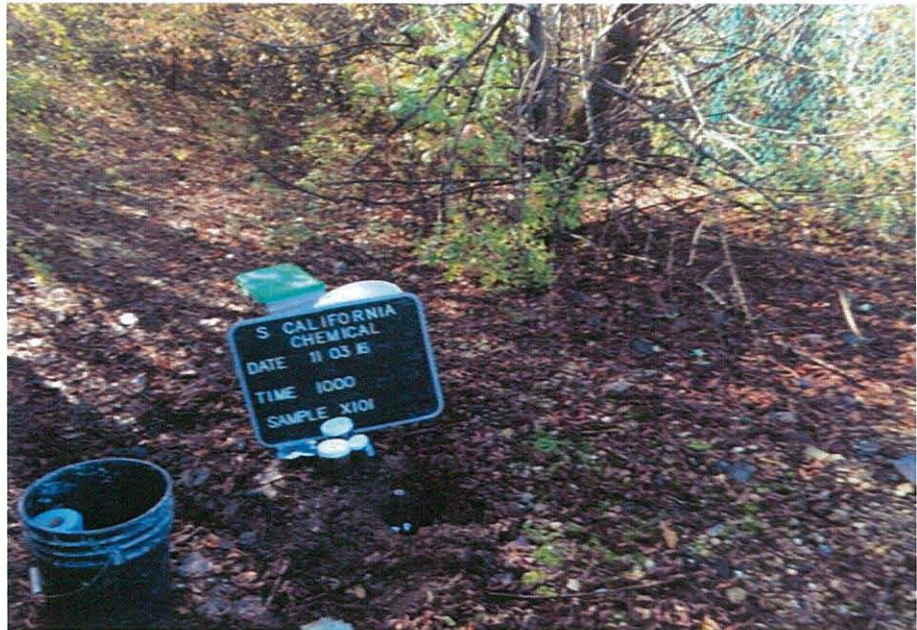
<b>DATE:</b>	11/3/2016
<b>TIME:</b>	10:00
<b>PHOTO BY:</b>	Dave Reed
<b>DIRECTION:</b>	South
<b>COMMENTS:</b>	X101 Sample collected at 7"

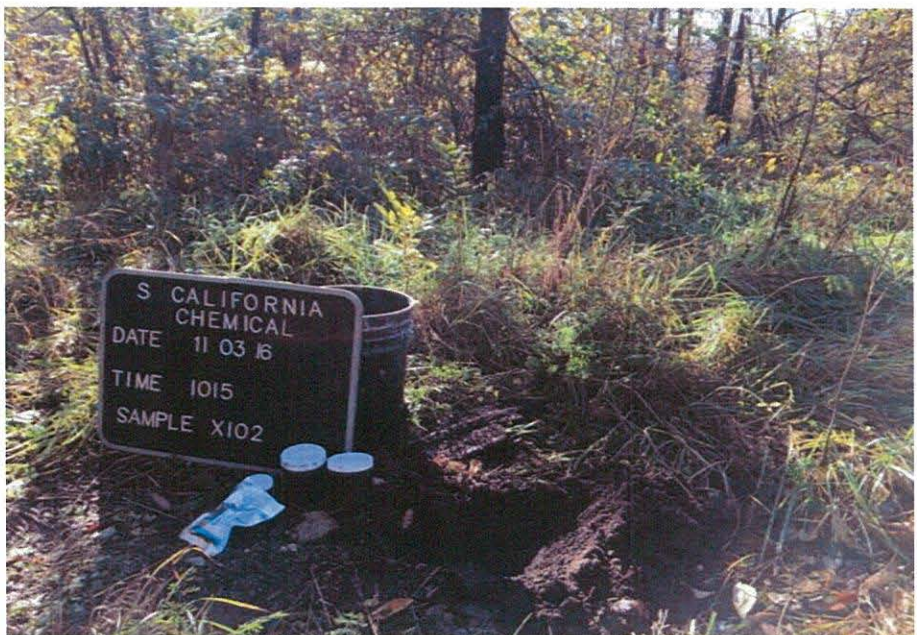
<b>DATE:</b>	11/3/2016
<b>TIME:</b>	10:15
<b>PHOTO BY:</b>	Dave Reed
<b>DIRECTION:</b>	South
<b>COMMENTS:</b>	X102 Sample collected at 5"

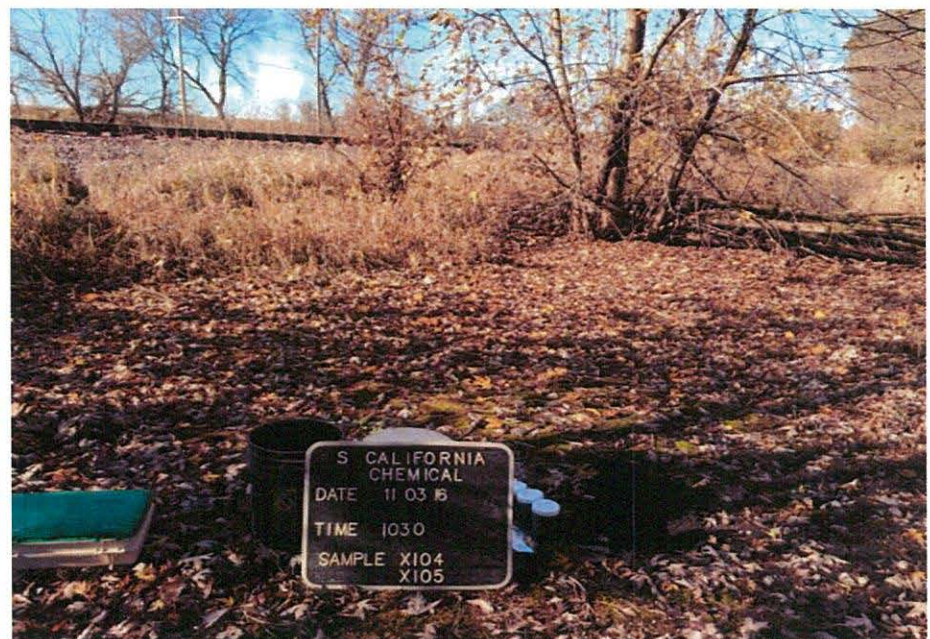
<b>DATE:</b>	11/3/2016
<b>TIME:</b>	10:30
<b>PHOTO BY:</b>	Dave Reed
<b>DIRECTION:</b>	Southwest
<b>COMMENTS:</b>	X104, X105
X105 is a field duplicate of X104	
sample was collected at 2"

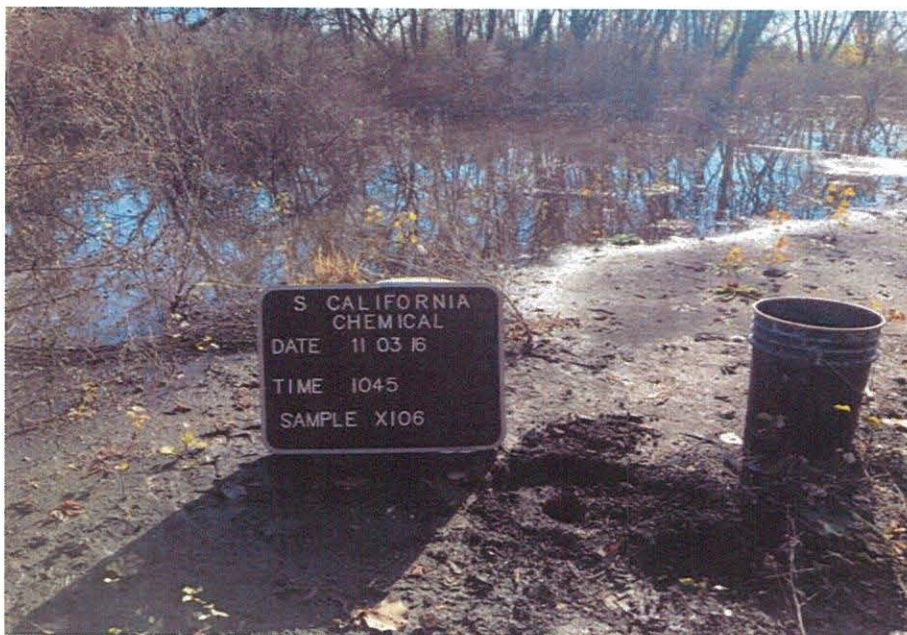
<b>DATE:</b>	11/3/2016
<b>TIME:</b>	10:45
<b>PHOTO BY:</b>	Dave Reed
<b>DIRECTION:</b>	Southeast
<b>COMMENTS:</b>	X106 Sample collected at 3"

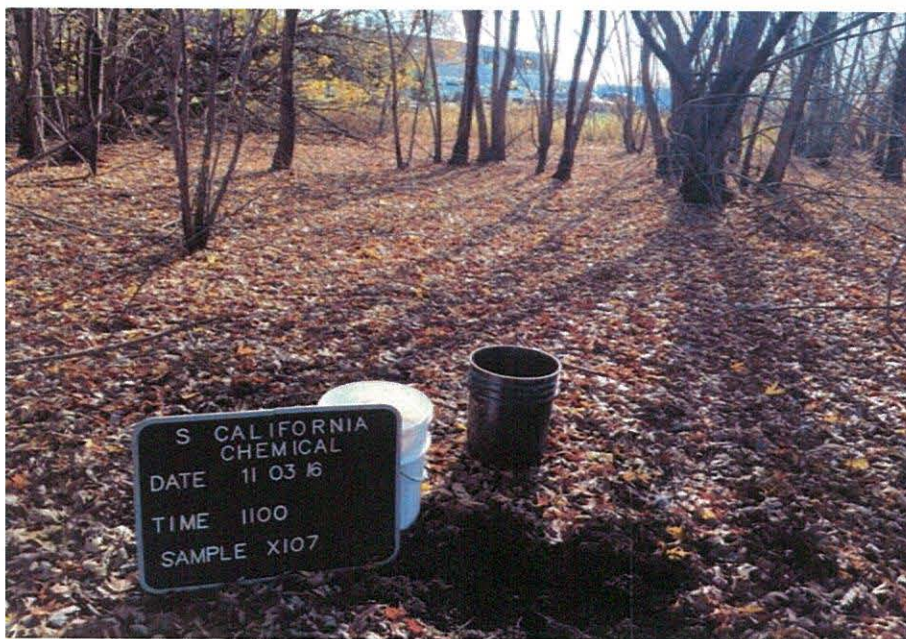
<b>DATE:</b>	11/3/2016
<b>TIME:</b>	11:00
<b>PHOTO BY:</b>	Dave Reed
<b>DIRECTION:</b>	Southeast
<b>COMMENTS:</b>	X107 Sample collected at 4"

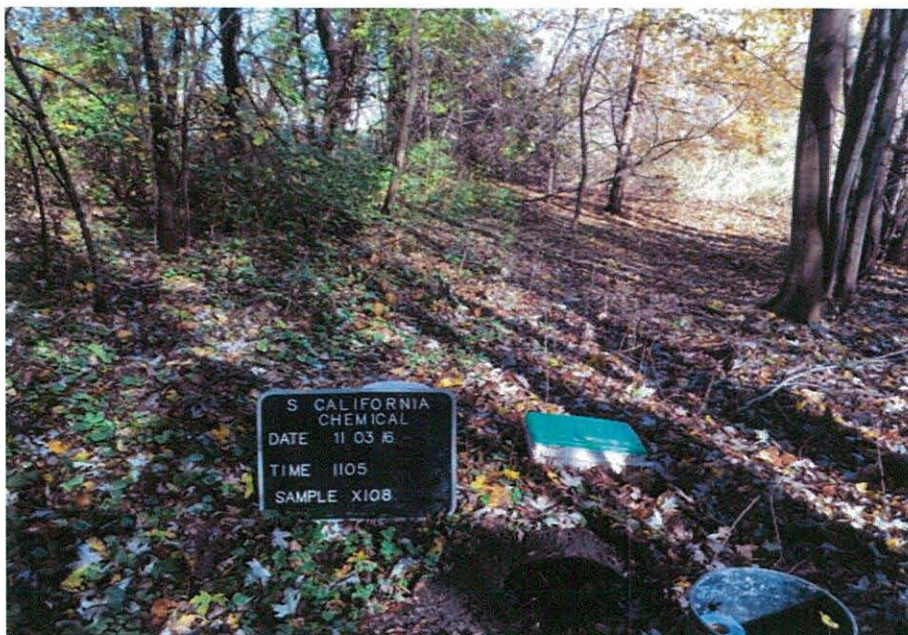
<b>DATE:</b>	11/3/2016
<b>TIME:</b>	11:05
<b>PHOTO BY:</b>	Dave Reed
<b>DIRECTION:</b>	North
<b>COMMENTS:</b>	X108 Sample collected at 3"

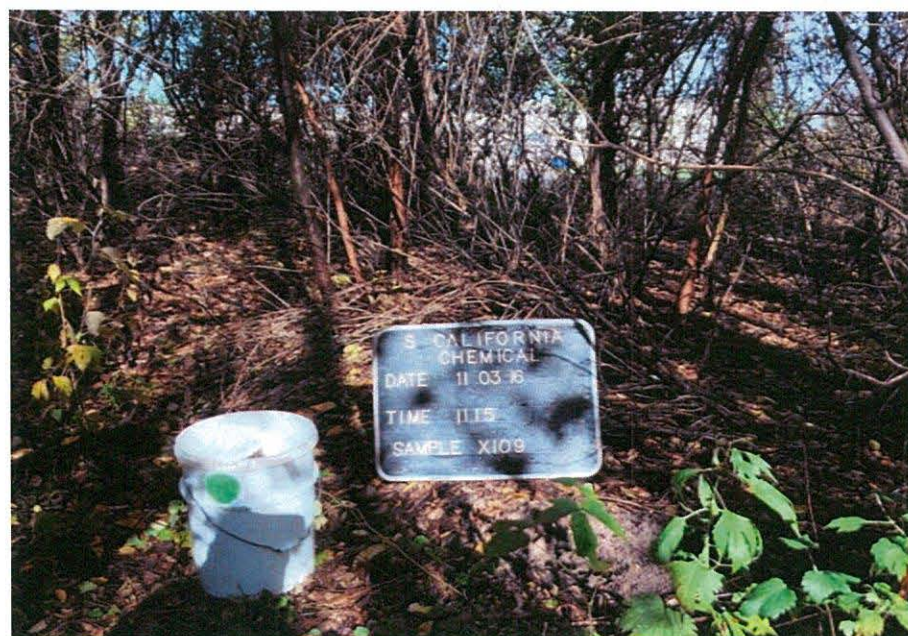
<b>DATE:</b>	11/3/2016
<b>TIME:</b>	11:15
<b>PHOTO BY:</b>	Dave Reed
<b>DIRECTION:</b>	North
<b>COMMENTS:</b>	X109 Sample collected at 1"

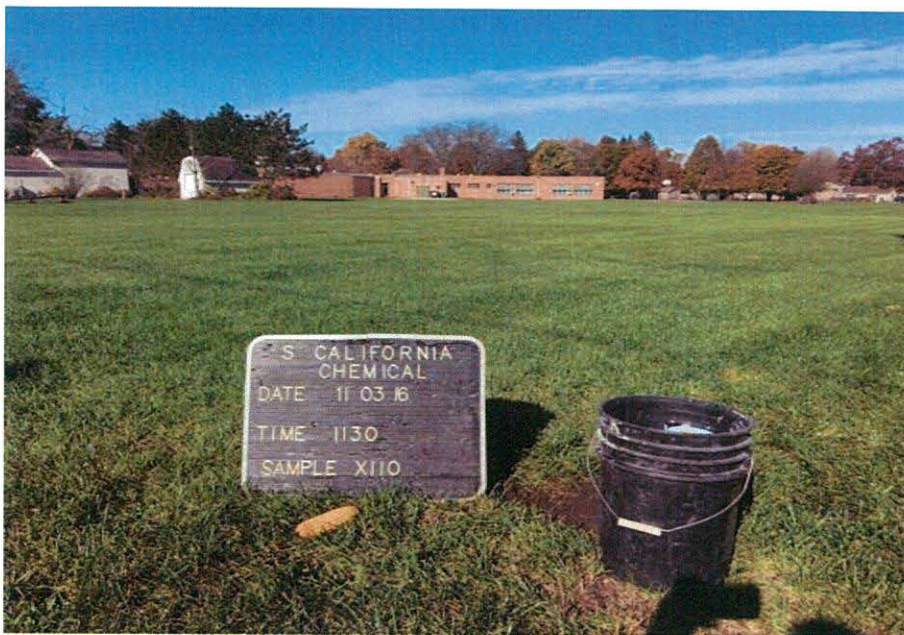
<b>DATE:</b>	11/3/2016
<b>TIME:</b>	11:30
<b>PHOTO BY:</b>	Dave Reed
<b>DIRECTION:</b>	Northwest
<b>COMMENTS:</b>	X110
Sample collected at 3"

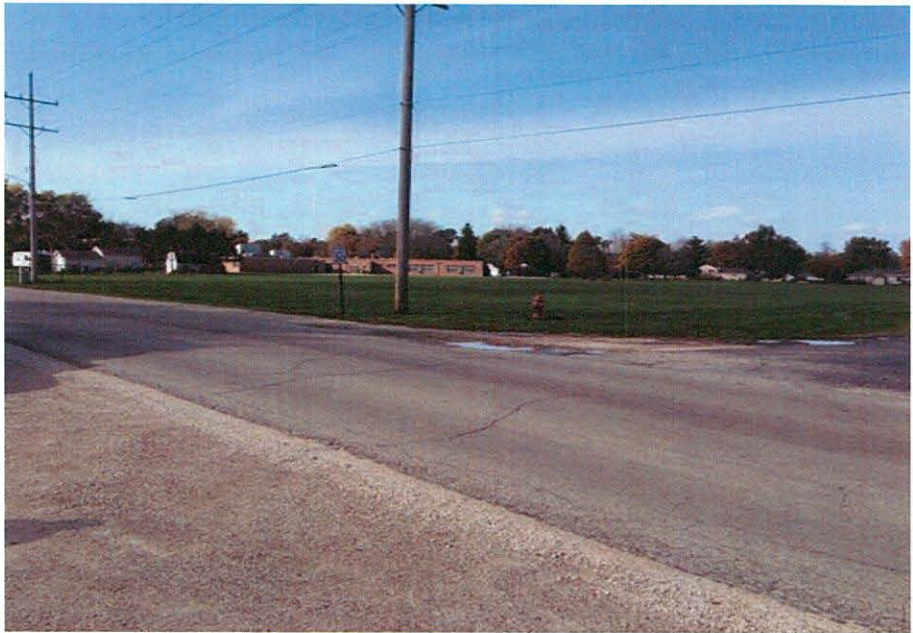
<b>DATE:</b>	11/2/2016
<b>TIME:</b>	15:45
<b>PHOTO BY:</b>	Dave Reed
<b>DIRECTION:</b>	Northwest
<b>COMMENTS:</b>	G101, G110 Sample G101, was taken over by the first telephone pole on the left side of the picture. The sample was taken just north of the utility flags in the picture. It is the same location as X110. Sample G110 is a duplicate sample of G101.

For the inorganic tests, multiple analytes were detected above the reporting limits. Three analytes, chromium, iron, and manganese, were noted to meet observed release criteria in samples G101/G110 and G103. Table 6 should be consulted for a complete list. Although most of the compounds detected are at levels typically seen as naturally occurring, the analytes that were detected were compared to Removal Management Levels (RMLs). In G101 and the duplicate sample of G101, G110, manganese was reported just above the RML of 1300ug/L. Lead at 19.7ug/L exceeded the MCL (15ug/L) in G103.

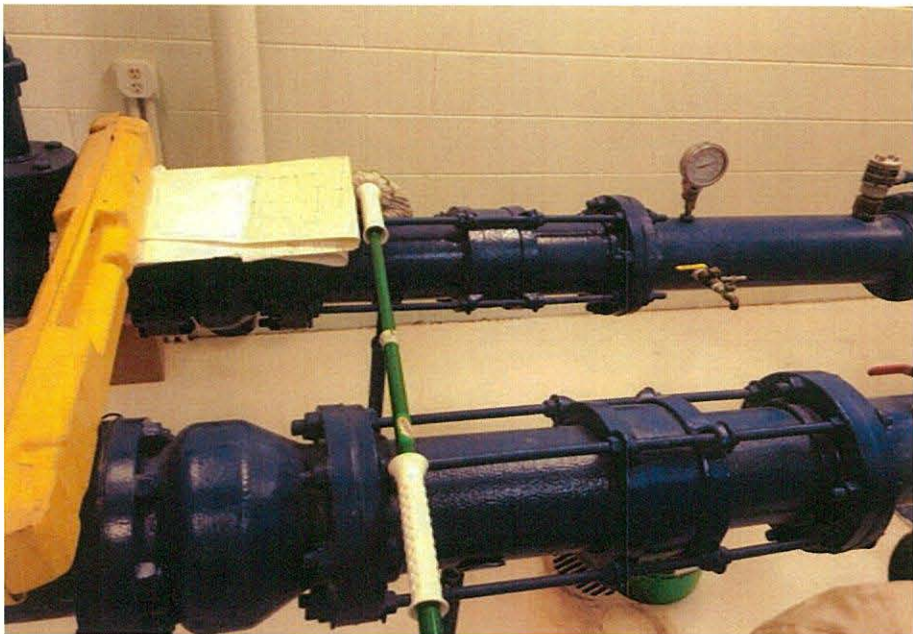
<b>DATE:</b>	11/1/2016
<b>TIME:</b>	16:15
<b>PHOTO BY:</b>	Dave Reed
<b>DIRECTION:</b>	South
<b>COMMENTS:</b>	G102 Sample G102, was collected before filtration at the city pumphouse for the well at this location. The sample was collected from the faucet directly under the pressure gauge on the blue pipe in this photo.

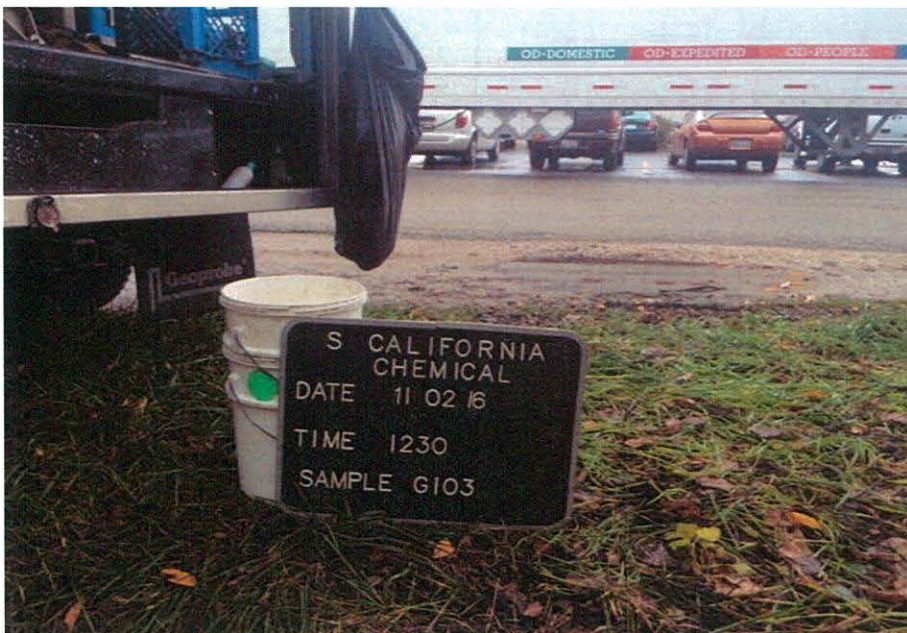
<b>DATE:</b>	11/2/2016
<b>TIME:</b>	12:30
<b>PHOTO BY:</b>	Dave Reed
<b>DIRECTION:</b>	North
<b>COMMENTS:</b>	G103

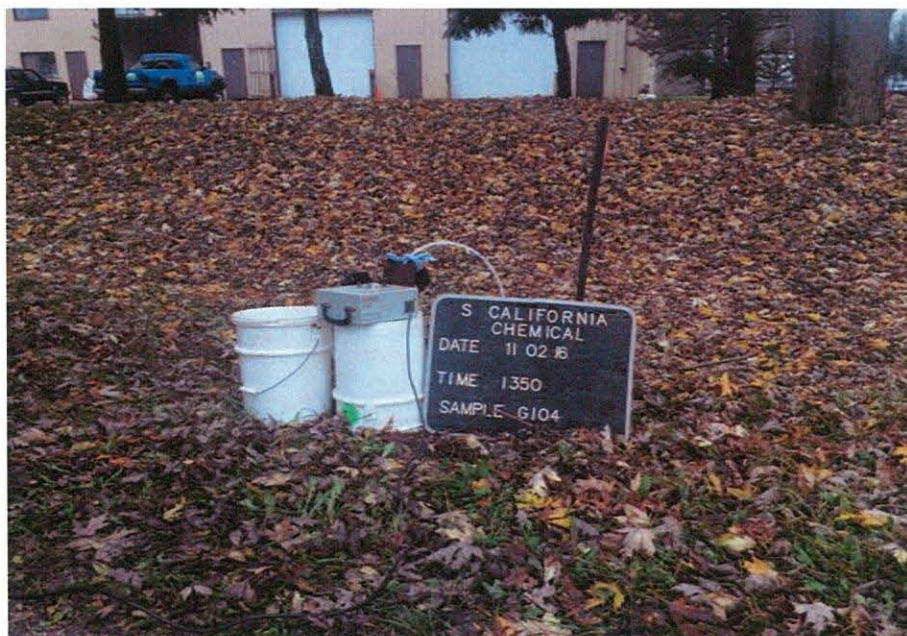
<b>DATE:</b>	11/2/2016
<b>TIME:</b>	13:50
<b>PHOTO BY:</b>	Dave Reed
<b>DIRECTION:</b>	South
<b>COMMENTS:</b>	G104
